INFORMATION HANDOUT

For Contract No. D01-0B3604

File: 01-HUM-36-PM 35.5-40.5
EA: 01-0B3601
EFIS ID: 0112000120
Storm Damage Repair

Subject: Geotechnical Design Recommendations, Dinsmore Slipouts/Sink

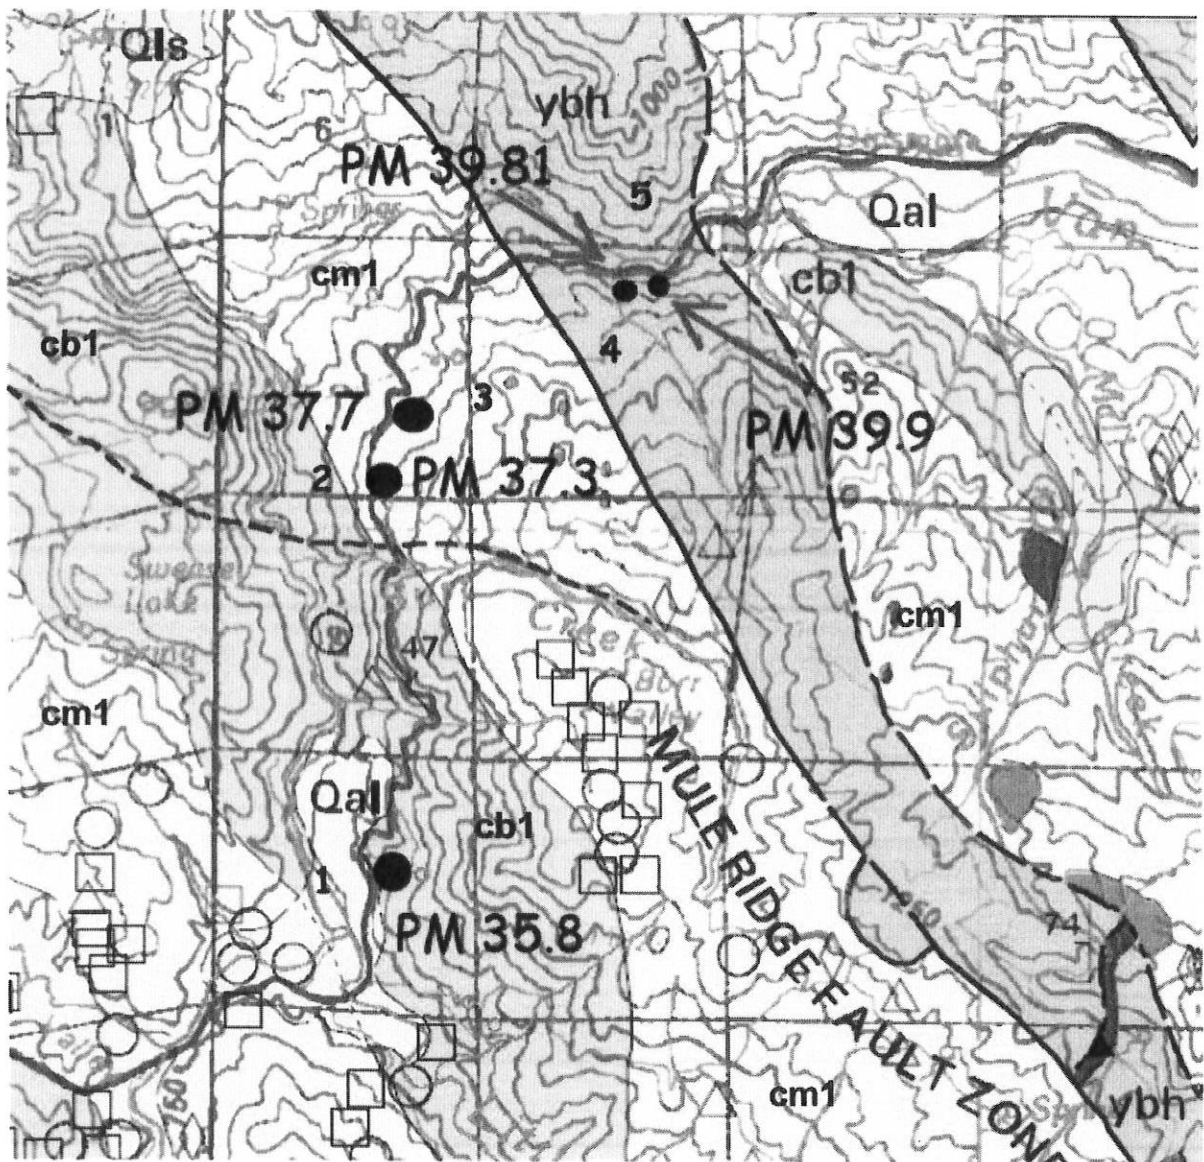
The project sites are underlain by the *mélange* and broken formation of the Central Belt Franciscan Complex and the metagraywacke of Hammerhorn Ridge of the Eastern Belt of the Franciscan Complex (Figure 2). Three locations are in the Central Belt of the Franciscan Complex: Location 1 (PM 35.8) is in unit cb1; Locations 2 and 3 (PM's 37.3 and 37.7) are in unit cm1. Locations 4 and 5 (PM 39.81 and PM 39.9) are in unit ybh of the Eastern Belt of the Franciscan Complex.

Figure 2. --Geologic map showing the locations of the five DAF's in Project 01-0B3601. All projects are located in the Franciscan Complex of the Coast Ranges Province.
